## CR06 “Error 2(ADC) & 10(RJC)”

### Diagnostic

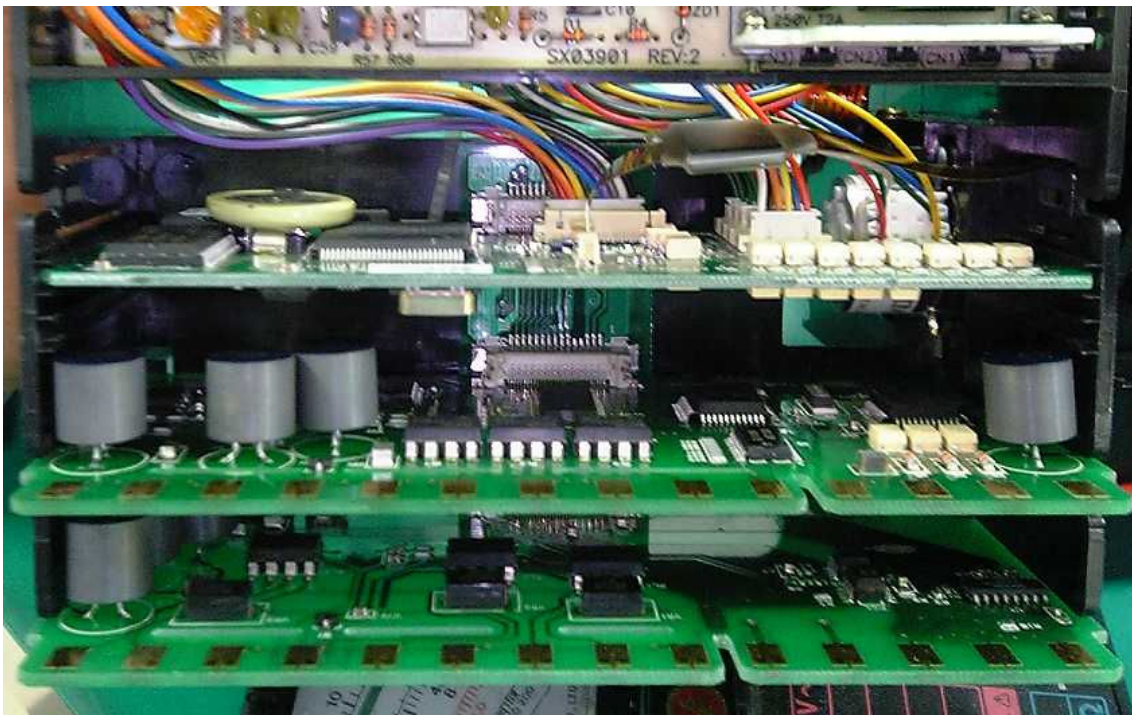
Please carefully to check each card (AI card, AI-sub card, CPU card) connected with back card connector.

Draw an inner module and check each card was connected definitely.

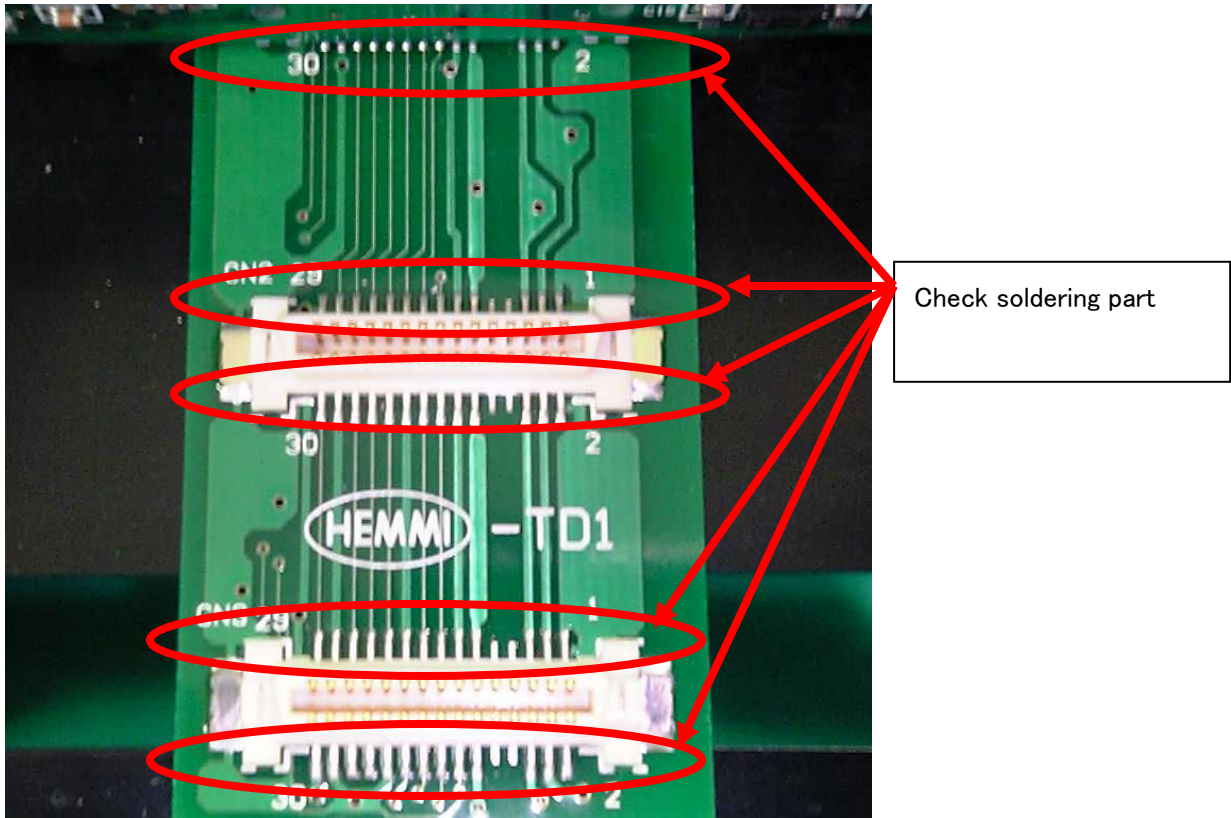
This card is back card which took out AI, AI-sub card.

Please check contacted failure of soldering

Check soldering part of back card connector.

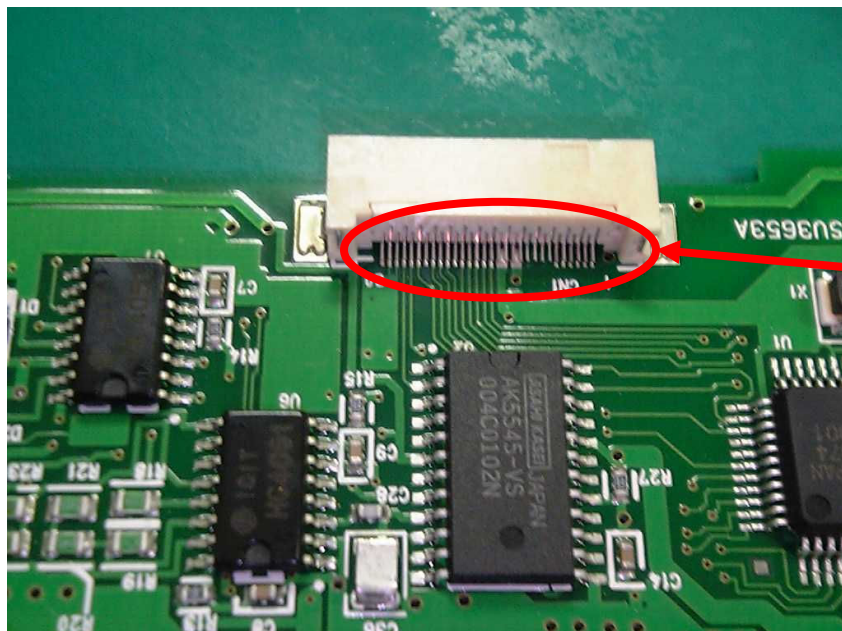
This is AI-sub card connector, please check contacted failure of soldering of each card.

Check soldering part

Check soldering part of AI, AI-sub, CPU card connector.
